**Test Report for:**  
**DBA DARE 2B DIFFERENT  
ENTERPRISES INC.**

**FIELD OF VIEW TEST  
One Rear Window Louver**

December 16, 2016  
Report No.: 102837293DET-001c

## FIELD OF VIEW TEST

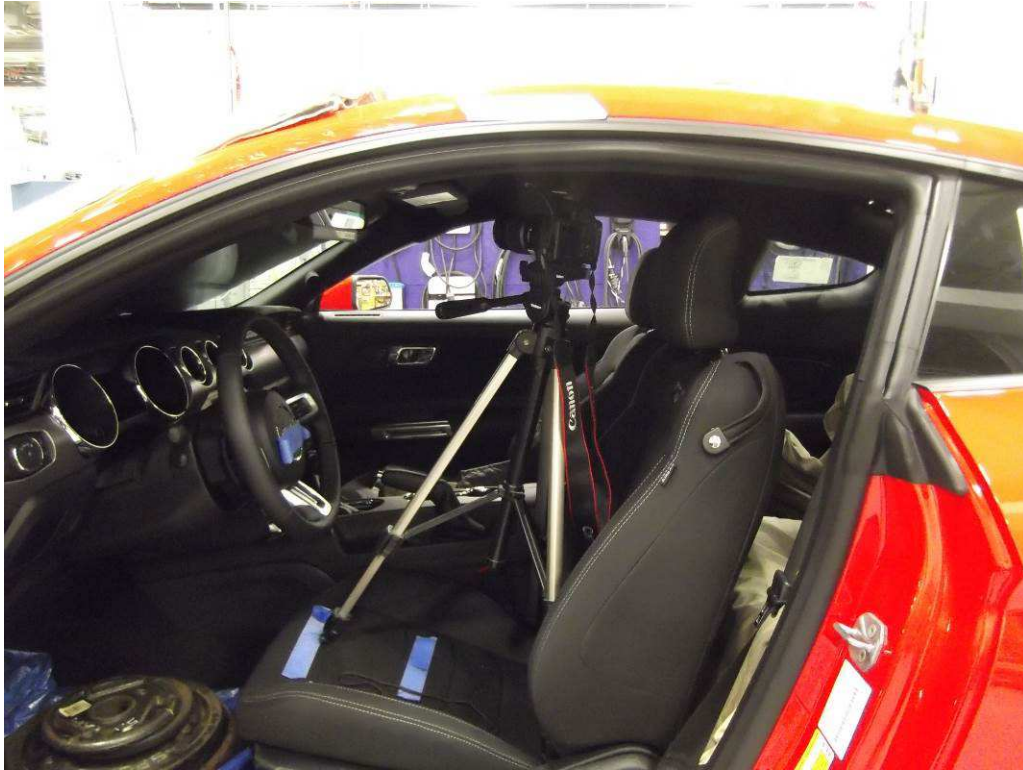
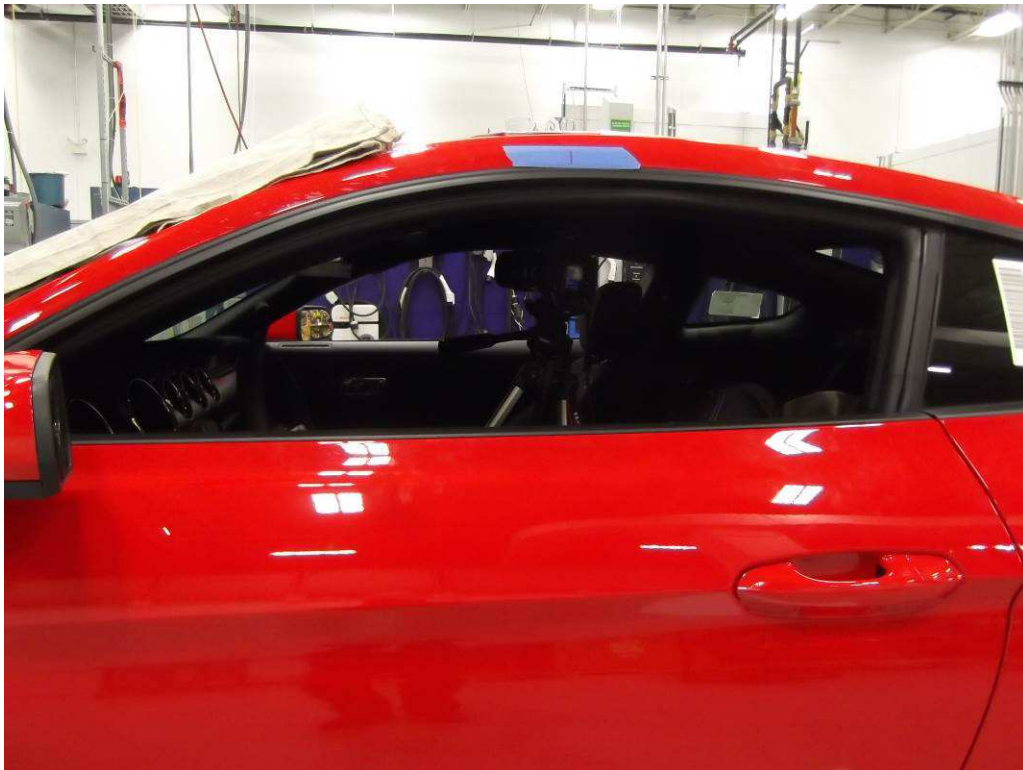
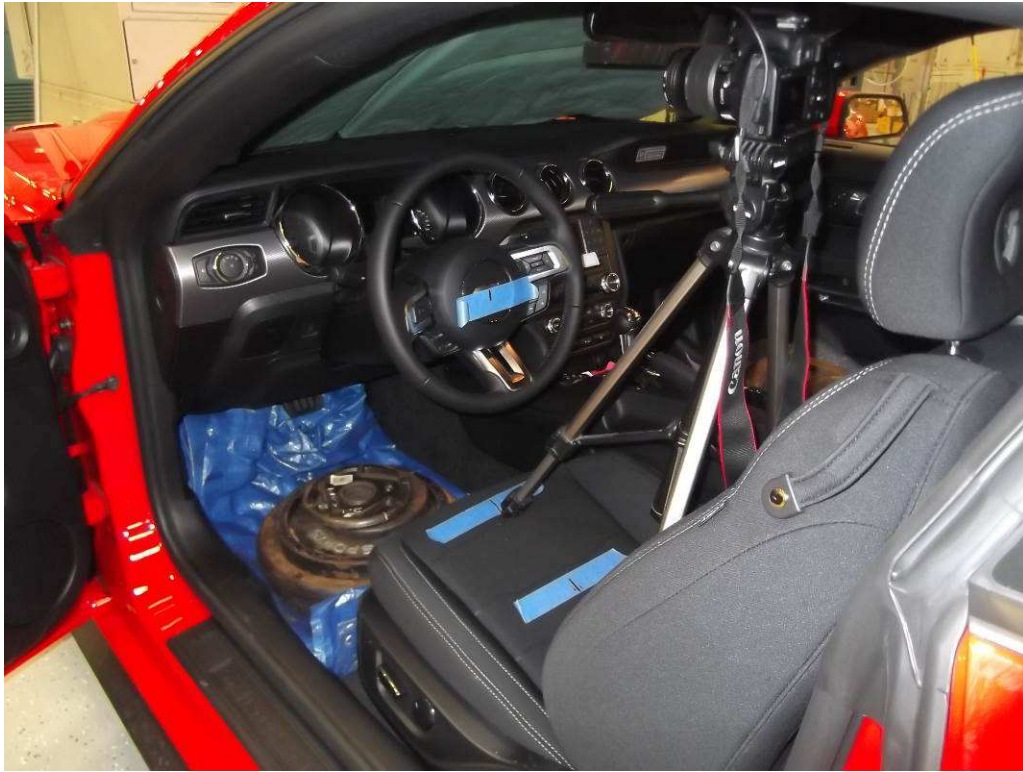
The driver seat was positioned at its lowest vertical adjustment with a distance from the front edge of the brake pedal to the front edge of the seat at 19 <sup>5</sup>/<sub>8</sub> inches, with the seat back at a 25° angle. The position of the camera and tripod in the seat was set up to resemble the human eye position. The center of the lens was 7 <sup>1</sup>/<sub>4</sub>" from the head liner and the front of the lens (retracted to 18mm) to the dashboard measured 22 <sup>1</sup>/<sub>2</sub> inches. The distance (*d*), between the center of the camera lens (retracted to 18mm) and the center of the rearview mirror was 18 <sup>1</sup>/<sub>2</sub> inches.

Photograph 1: Camera Placement

Photograph 2: Camera Placement

Photograph 3: Camera Placement

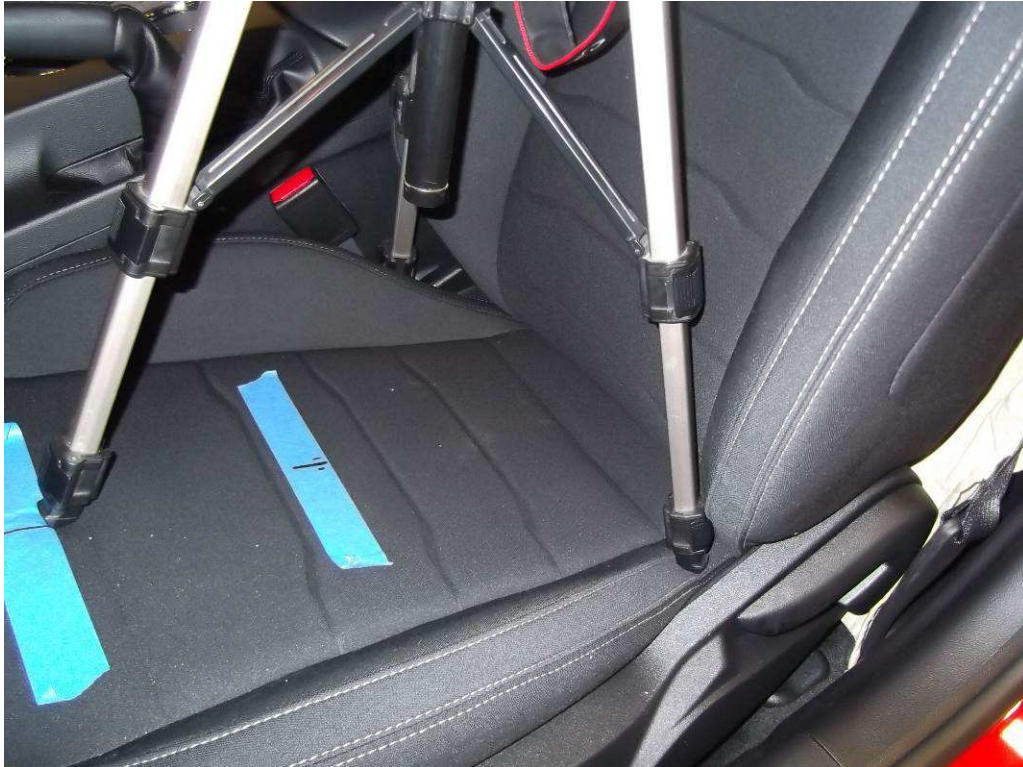
Photograph 4: Camera Tripod Placement

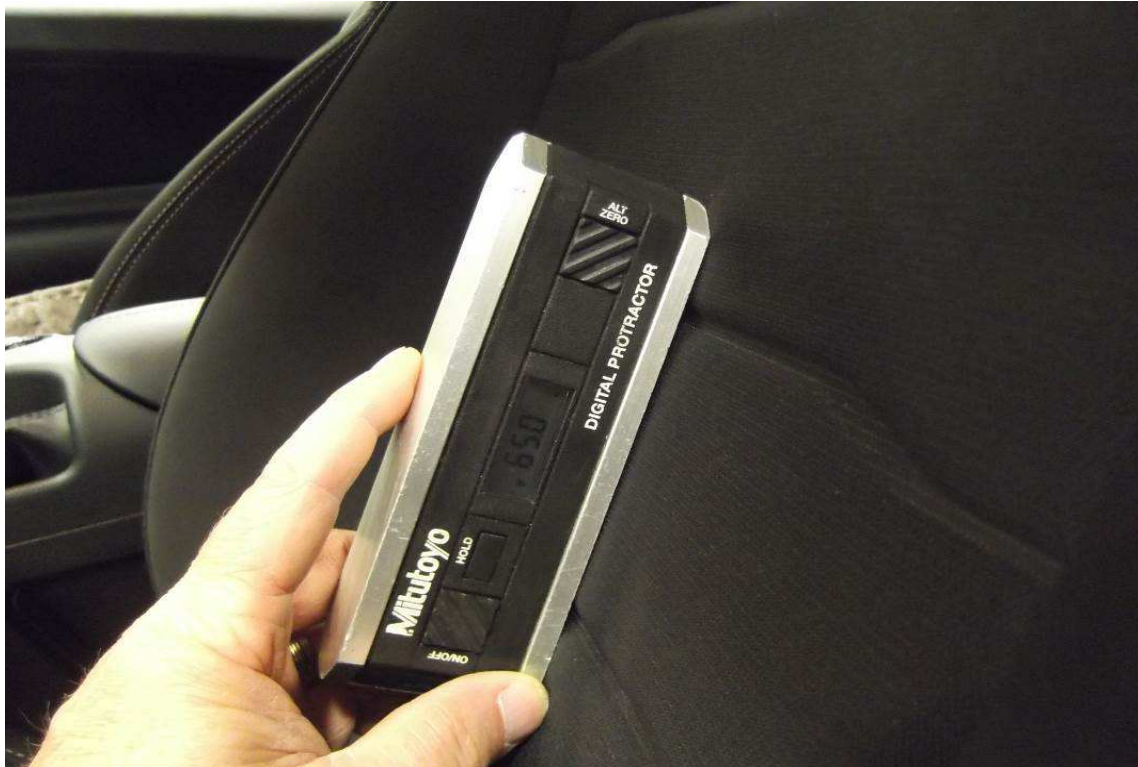
Photograph 6: Seat Back Angle

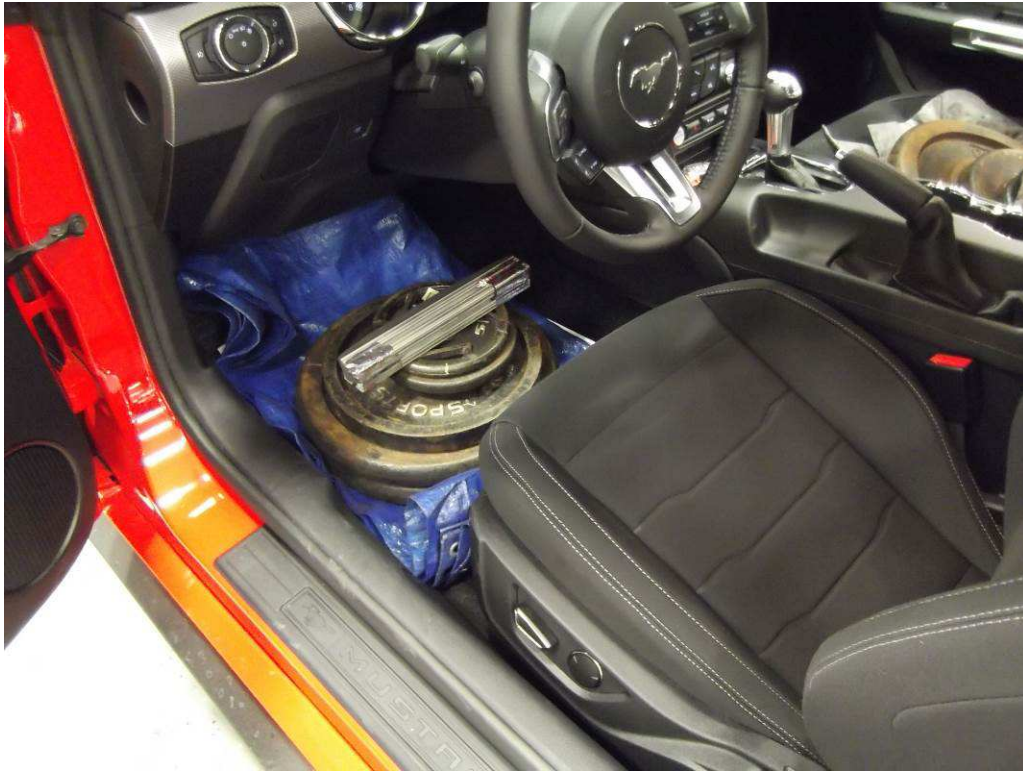
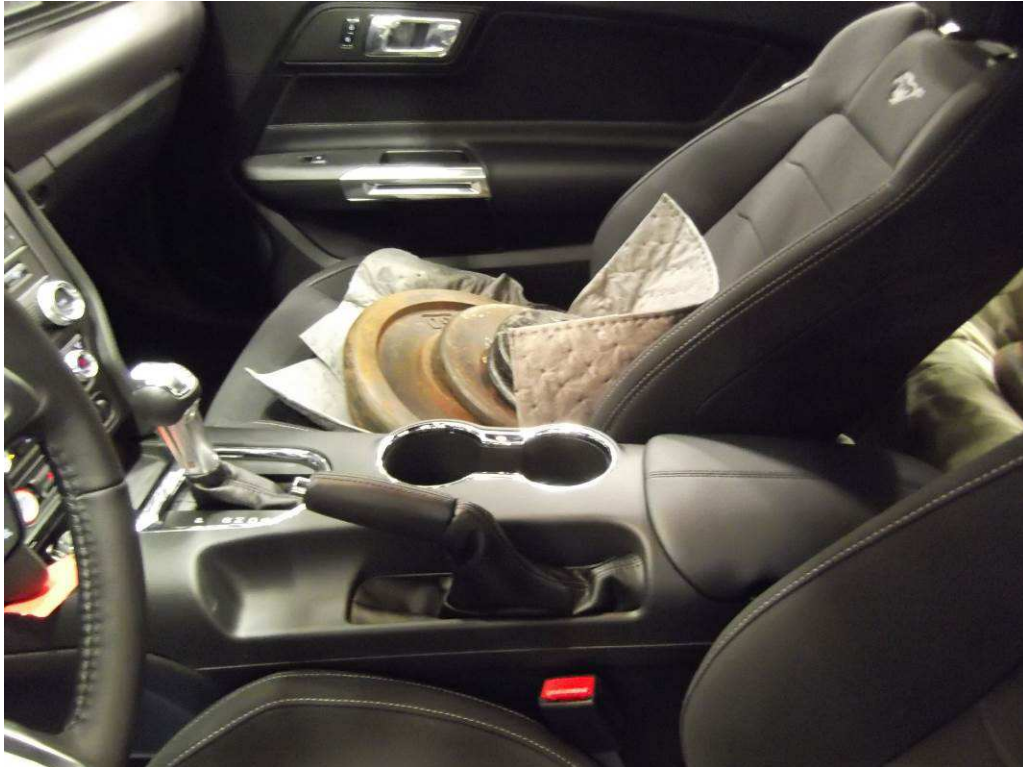
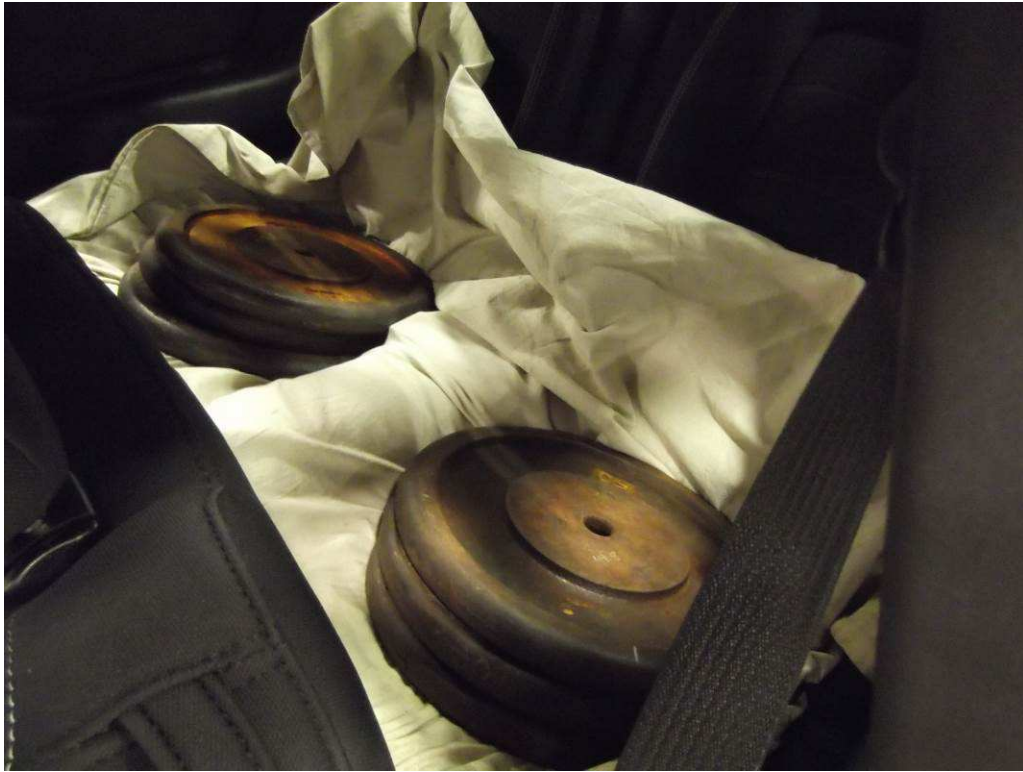
A 2017 Ford Mustang GT Coupe; VIN#1FA6P8CF9H5237093 was placed on a smooth level concrete surface at ambient conditions (23°C). The tire pressure was set to 32PSI on all four tires per manufacturers recommendations. A weight plate was placed in each seating area 150.2lbs on the left rear seat, 150.3lbs on the right rear seat, 149.4lbs on the passenger seat and 149.9lbs in the driver side floor. The gas tank was filled to capacity and the windows were cleaned and clear of any obstructions.

Photograph 9: Weights on the Driver's Side

Photograph 10: Weights on the Passenger Side

Photograph 11: Weights on the Rear Seats

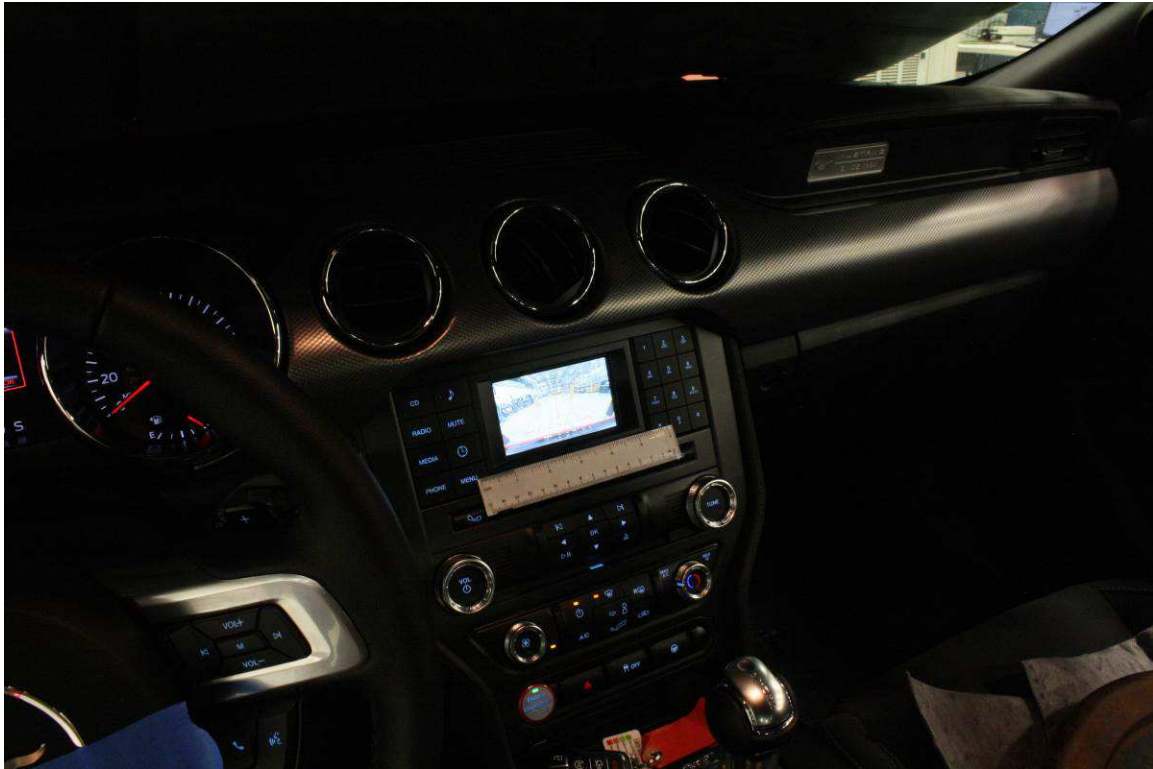
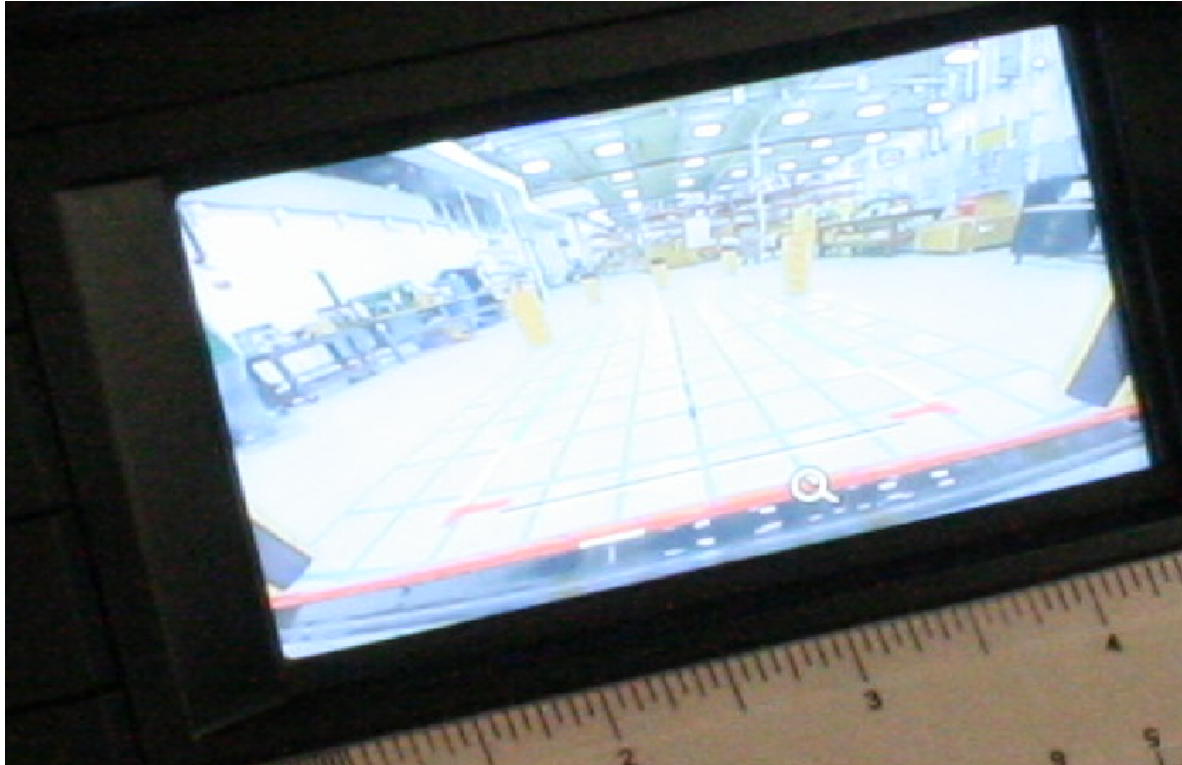
Finally, a ruler was affixed to the base of the rearview display, level with the ground. The ruler was included to be used as a scaling factor. A photograph was recorded of the rearview video display incorporated into the Ford Mustang (See photographs 23 and 24 in Appendix A).

Photograph 23: In Car rearview monitoring system

Photograph 24: Zoomed In View Of Photograph 23

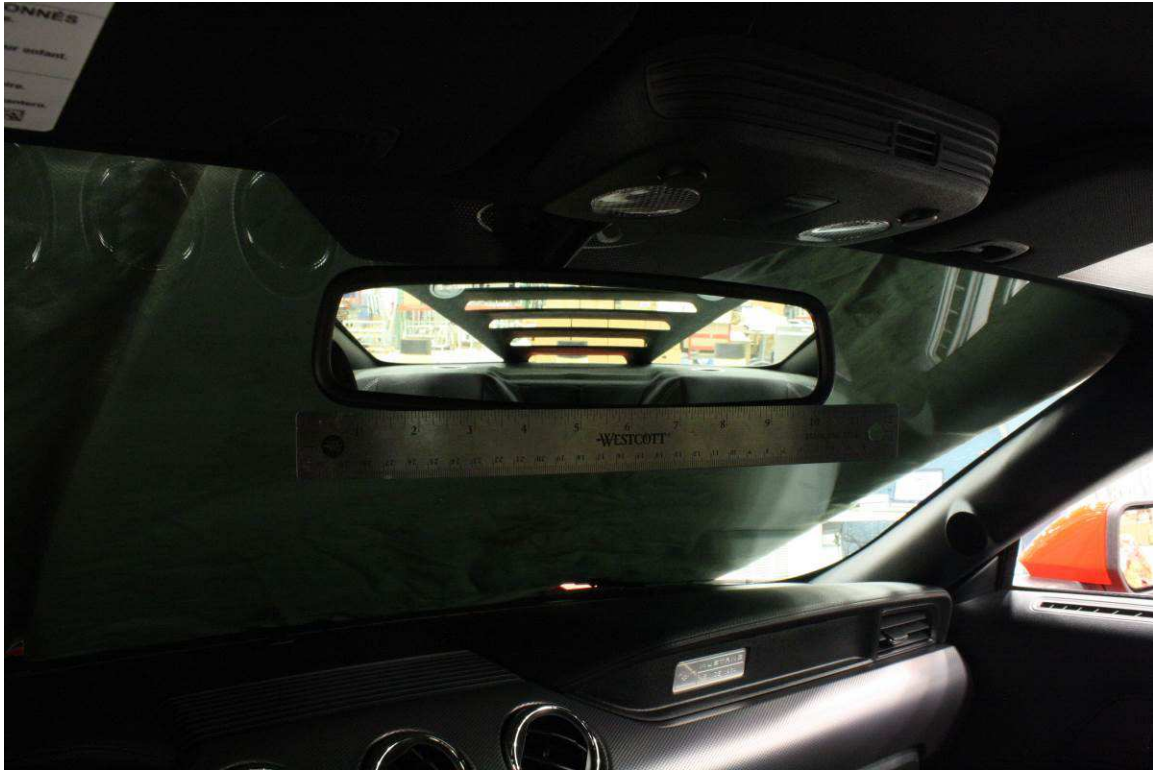
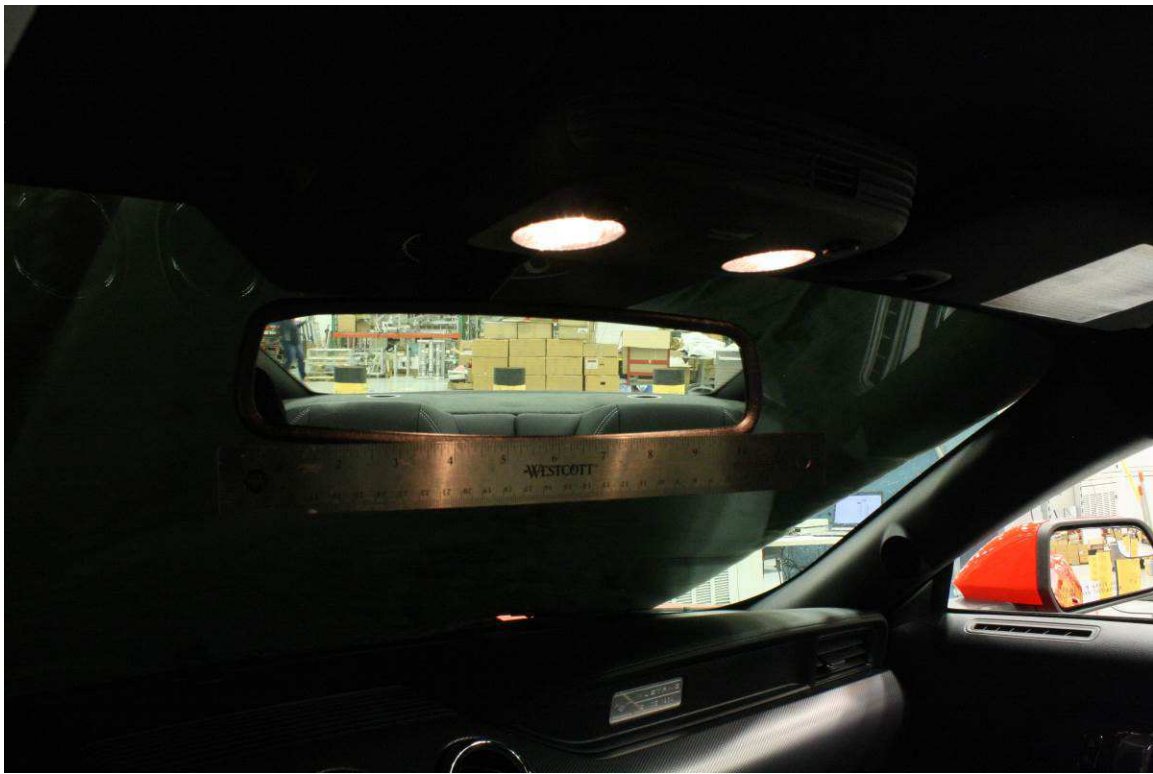
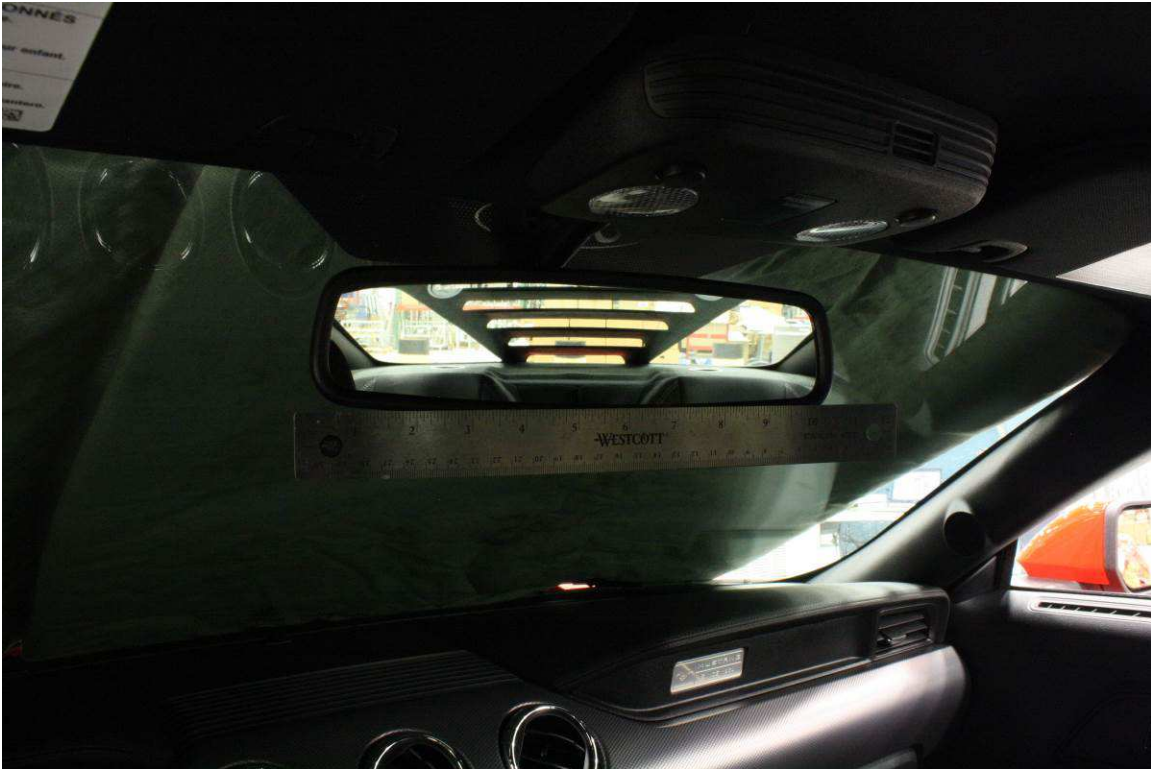
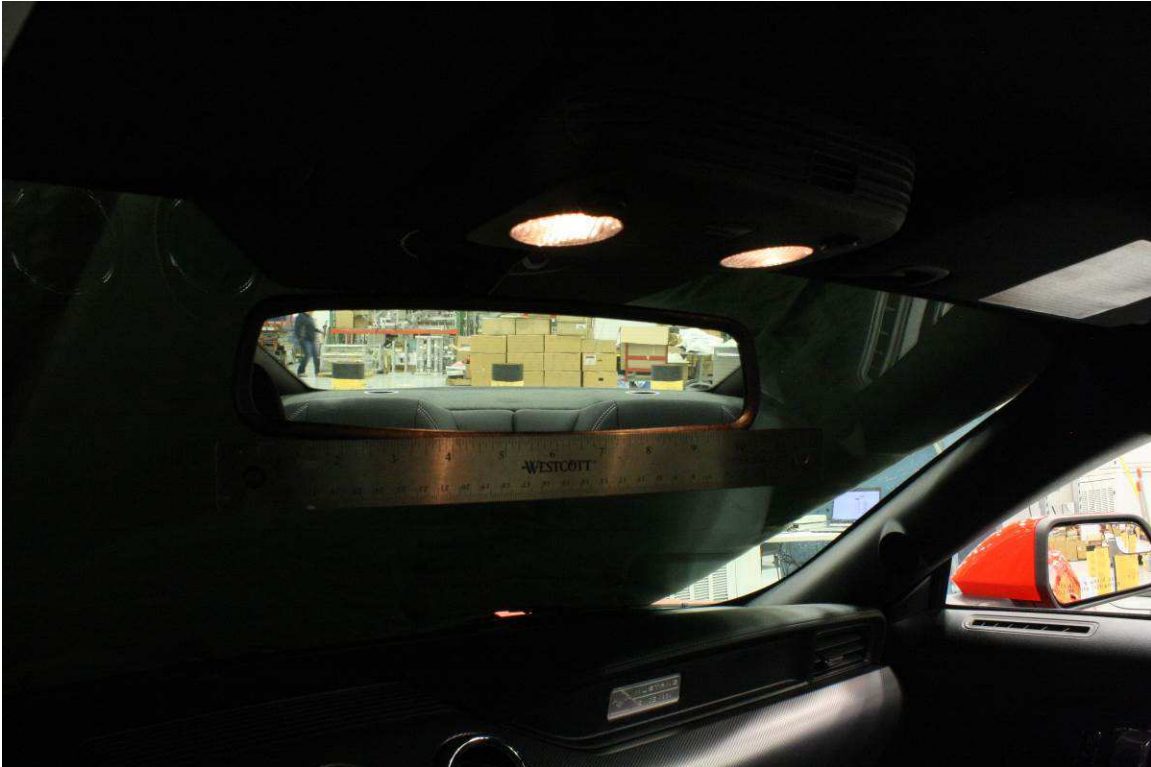
Photograph 25: Grid And Cylinders With Louver

Photograph 26: Grid And Cylinders Without Louver

Photograph 27: Grid And Cylinders With Louver

Photograph 28: Grid And Cylinders Without Louver

An evaluation was conducted to determine if the field of view and visual image was of a sufficient quality to permit the average driver to discern critical objects located within the field of view. With the test article removed from the rear window of the vehicle, the horizontal stripes on cylinders A, B and C were visible in the viewing plane. Likewise, with the test article applied to the rear window of the vehicle, the horizontal stripes on cylinders A, B and C were visible in the viewing plane (See photographs 25, 26, 27 and 28 in Appendix A).

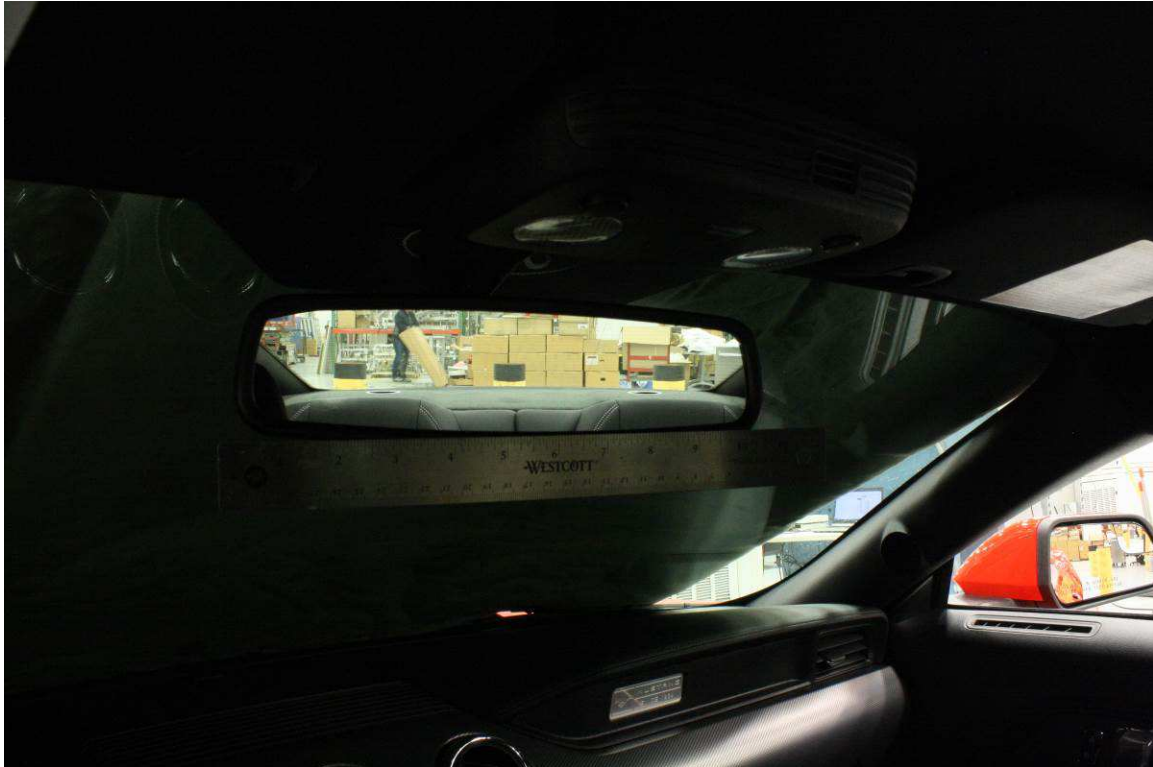
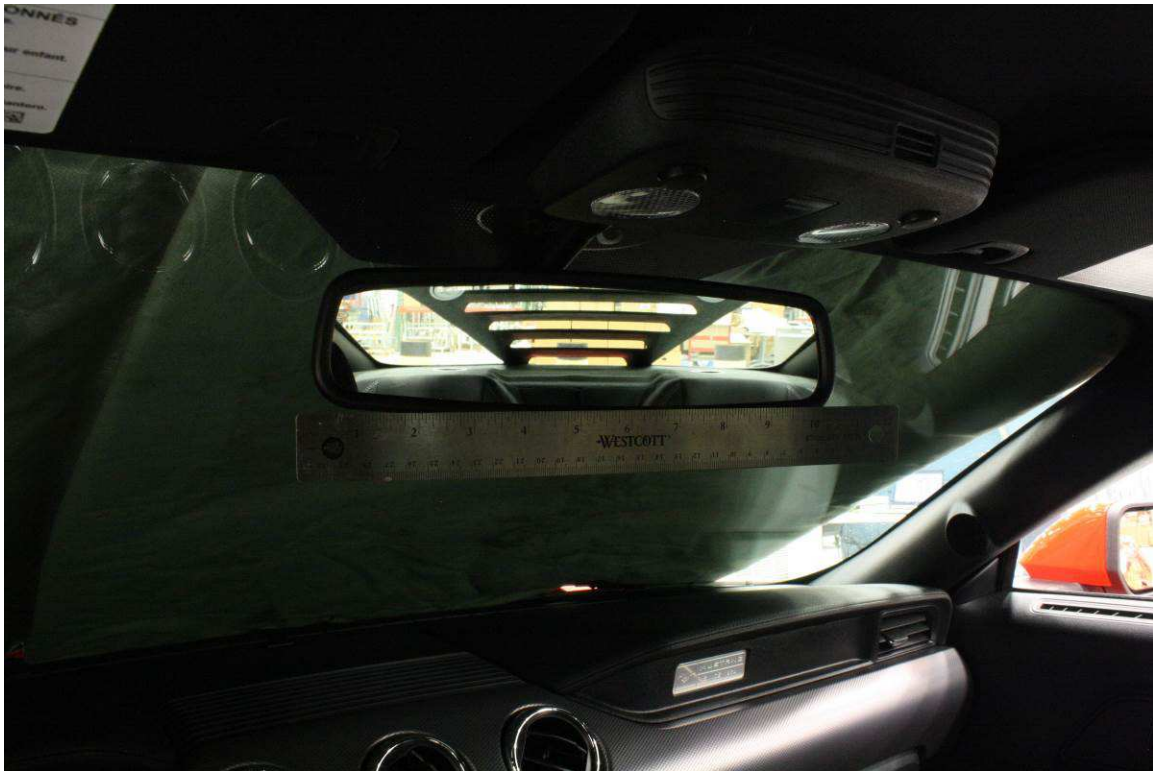
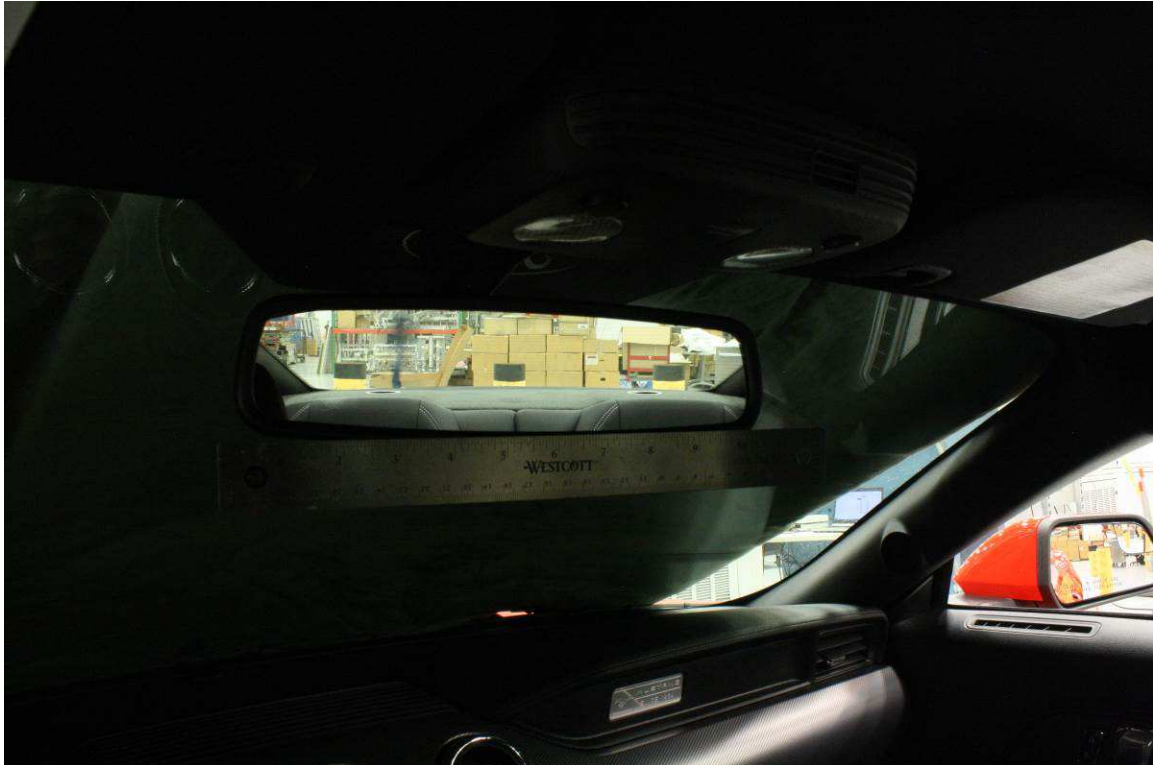
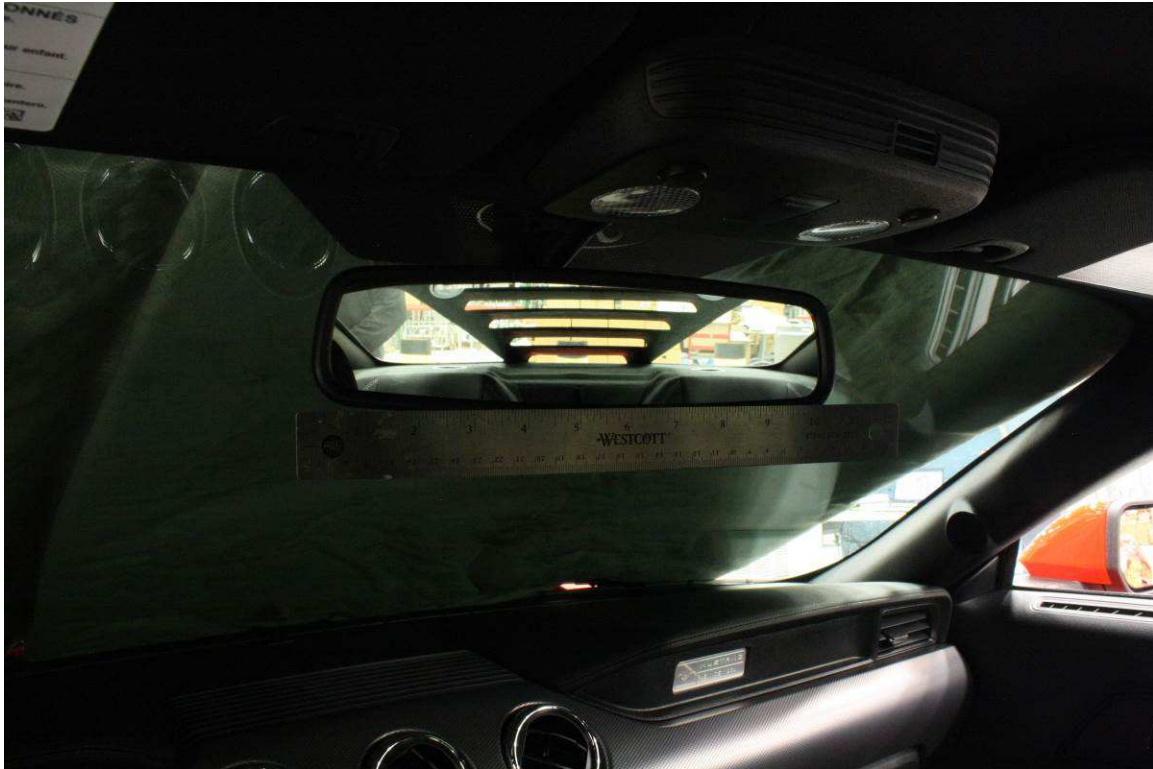
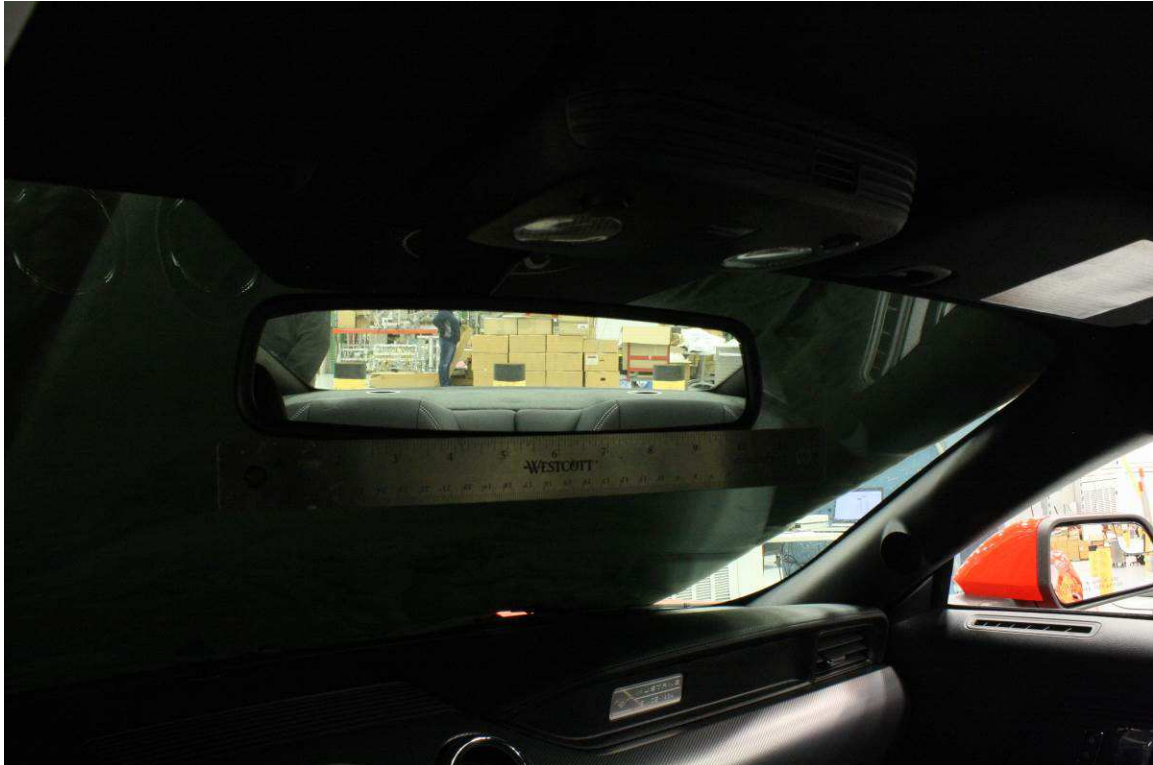
Photograph 29: Location A With Louver

Photograph 30: Location A Without Louver

Photograph 31: Location B With Louver

Photograph 32: Location B Without Louver

Photograph 33: Location C With Louver

Photograph 34: Location C Without Louver

Finally, a subjective evaluation was conducted to determine if the field of view provided enough visibility to a driver to have the best opportunity to discern obstacles, such as pedestrians, located within the field of view. It was determined that the driver has equal opportunity to discern obstacles in the field of view with the test article applied as with the test article removed. (See photographs 29 through 50 in appendix A).
